No. 753

MEASUREMENT OF THE FORCES ACTING ON GLIDERS IN TOWED FLIGHT

By W. B. Klenperer  
The Soaring Society of America, Inc.

Washington  
February 1940

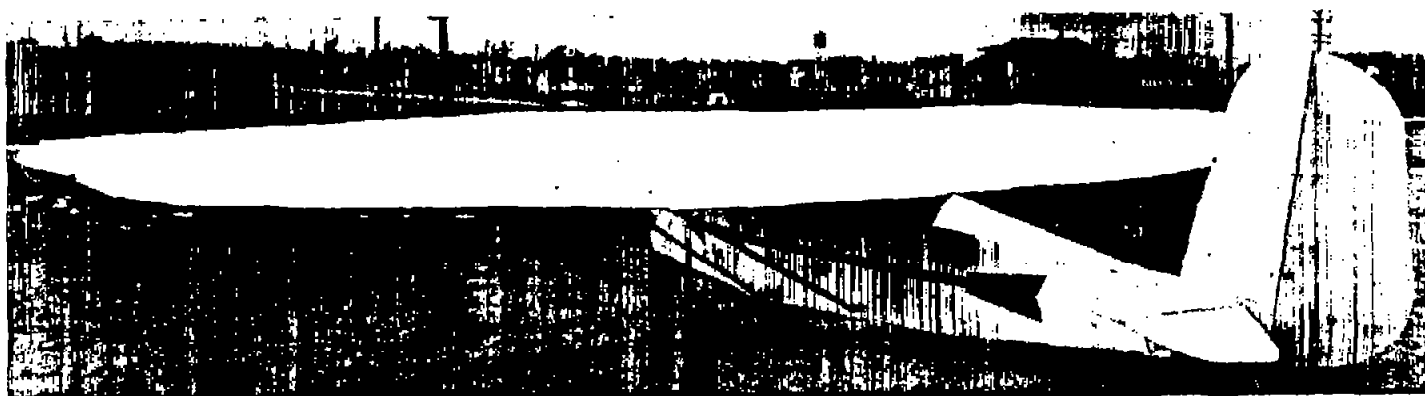
Figure 1.- Utility cadet type of glider used for group I of glider tow tests.

The glider used in the first group of tests was a Cadet of the Secondary Training or General Utility type, a high-wing monoplane, license No. G10265, owned by Richard Randolph of Akron, Ohio. It was constructed as shown on the attached photograph (fig. 1) except that jury struts and additional tail-bracing wires were provided (as authorized by the Bureau of Air Commerce). The wing span of the glider was 37 feet 10 inches; length, 18 feet 9 inches; wing area, 160 square feet. The weights were as follows:

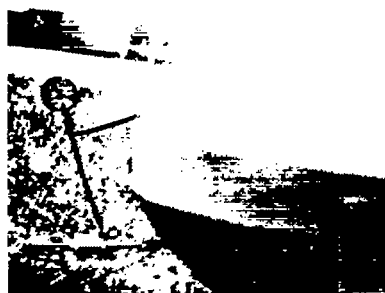
Figure 12.- Tensiometer installation for group III of glider tow tests.

A 16-mm motion picture camera was mounted on an outrigger from the wing of the glider to photograph the pressure-gage dial of the dynamometer, as shown in figure 12. Vibrations blurred some of the exposures but most of them were legible to the nearest 10 pounds. The camera could be started by the glider pilot pulling on a string and it would then run for a maximum duration of 40 seconds. The camera was also meant to photograph the air-speed meter and the towline angle. Data from neither could be evaluated from the film, however, because the sun glare blotted out the hand and dial of the air-speed indicator and perspective caused the towline angle to appear too much foreshortened. No longer outrigger was available to move the camera more squarely abreast the dynamometer. The camera speed was approximately 20 frames per second.
